Fault Zone – Rotor

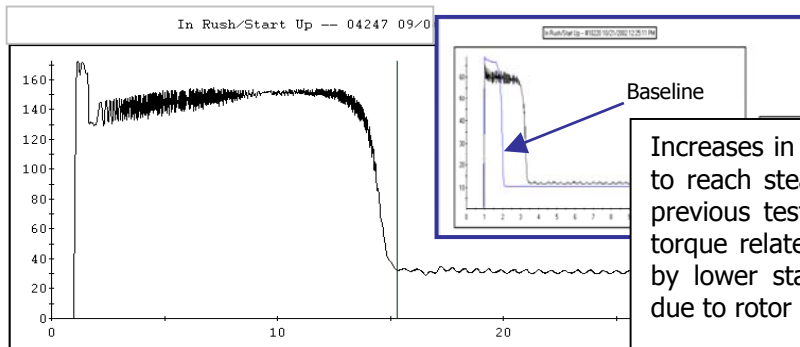
Increases in the start-up time required to reach steady state as compared to previous tests are a result of load or torque related issues and are affected by lower start-up current and torque due to rotor defects or lower voltage.
